Section 13 Asset Class – Traffic Safety Structures & Devices:

The Traffic Safety Structures & Devices asset class includes all of the SDOT assets whose main purpose is to provide a reasonably safe transportation system. It includes:

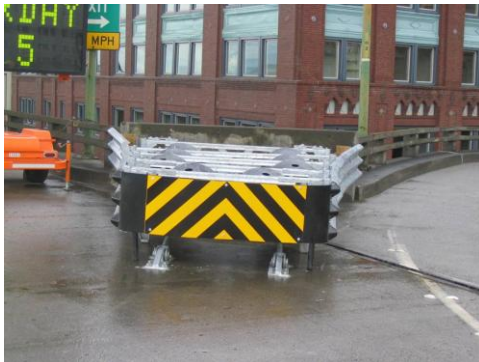
Crash Cushion

A crash cushion is a disposable device used to increase safety for motor vehicle operators and passengers who collide with safety barriers in gore areas. Crash cushions improve safety and also help protect the transportation infrastructure.

Crash cushions are not regularly inspected and are maintained on a customer request or incident basis. Age is used in determining a replacement cycle. When newly installed, the expected useful life of a crash cushion is ten (10) years. It degrades to fair condition in eight (8) years, and, at the end of its useful life, it is considered in poor condition and is eligible for replacement. If a crash cushion is damaged in a collision, it is replaced. The 2008 inventory collected the following condition data on crash cushions.

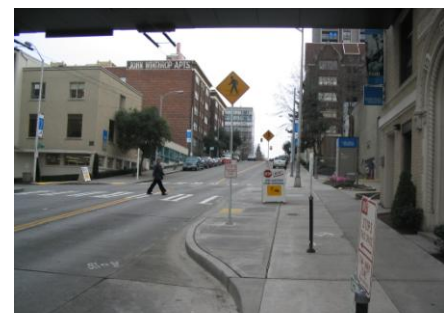
Curb Bulb

Curb bulbs are extensions of the sidewalk or curb line into the parking lane that physically narrow the roadway, thereby reducing pedestrian crossing distance. Curb bulbs improve pedestrian safety by increasing the amount of protected, dedicated space for walking and encourage walking as a mode of transportation.

Curb bulbs are not regularly inspected and are maintained on a customer request basis. Age is often used as a surrogate for the condition of a curb bulb. When newly installed, the expected useful life of a curb bulb is twenty (20) years if asphalt, and forty (40) years if concrete. It degrades to fair condition in fifteen (15) years if asphalt, and thirty (30) years if concrete. At the end of its useful life, it is considered in poor condition and eligible for replacement.

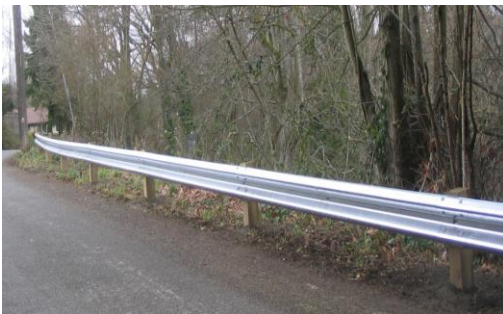
Typical Guardrail

Guardrails are devices designed to keep pedestrians and motor vehicles from straying off the road into potentially dangerous or off-limit areas of the ROW. Guardrails improve safety and also protect the transportation infrastructure.

Guardrails are not regularly inspected and are maintained on a customer request basis. Age is used in determining a replacement cycle.. When newly installed, the expected useful life of a guardrail is 25 years. It degrades to fair condition in 17 years, and, at the end of its useful life, it is considered in poor condition and eligible for replacement. The filed inventory conducted in 2008 collected the following data on condition:

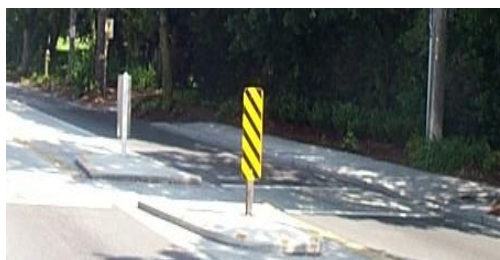
A median island is a physical barrier that divides a street into two or more roadways. It serves as a place of refuge for pedestrians crossing the roadway and also restricts certain vehicular turning movements. Median islands increase safety and also encourage walking as a mode of transportation.

**Pedestrian Refuge Island, a Type of
Median Island**

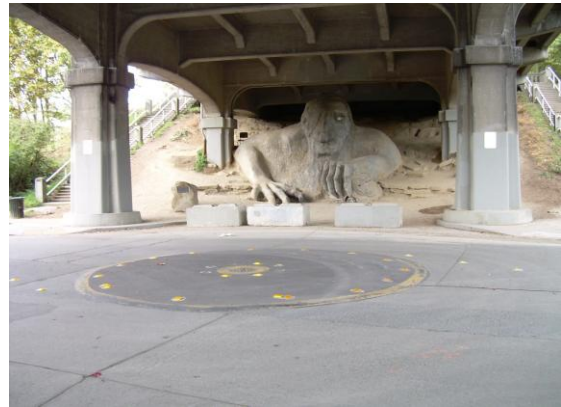
Speed Dot

A speed dot is a raised section of pavement in the middle of an intersection that is intended to slow traffic.

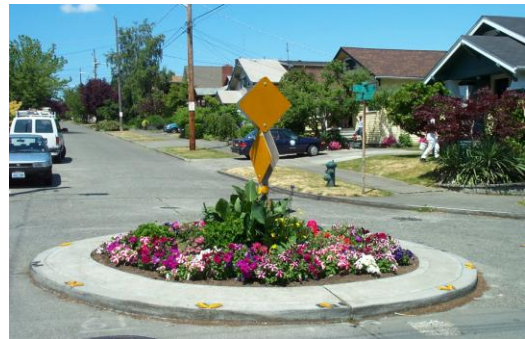
Traffic circles are raised islands constructed at intersections of residential streets. Traffic circles provide separation of oncoming vehicles and cause motorists to decrease speed. Many of the traffic circles include landscaping that is maintained by a neighborhood group. Traffic circles increase safety for pedestrians and bicyclists and encourage walking and bicycling as modes of transportation. When landscaped, they also contribute to a more vibrant neighborhood.

Traffic Circle with Landscaping

Traffic circles are not regularly inspected and are maintained on a customer complaint basis. Age is used in determining a replacement cycle. When newly installed, the expected useful life of a traffic circle is 25 years. It degrades to fair condition in seventeen (17) years. At the end of its useful life, it is considered in poor condition and eligible for replacement. The inventory conducted in 2009 also determined condition ratings of the traffic circles as follows:
